# **Airfield Pavement Condition Evaluation**

## **Missoula International Airport**

Prepared for  
**Missoula County Airport Authority**

OCTOBER 2008

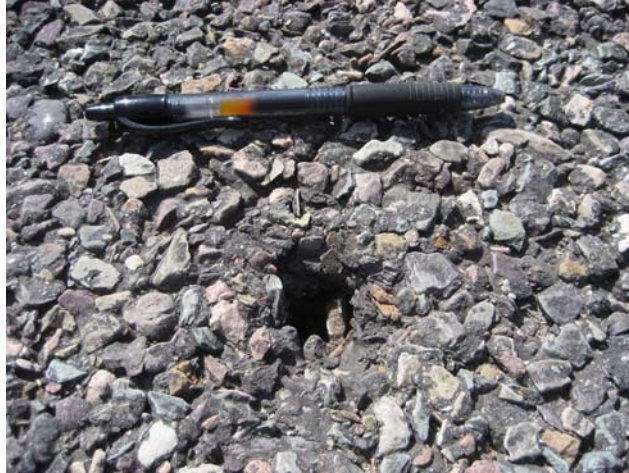
The surface of Taxiway A is PFC and is divided into five sections with a range of PCI values from 59 to 86. Various portions of the taxiway have been rehabilitated in four separate projects between 1993 and 2005. The older portions are in fair condition. On the west end of the taxiway, there were very few cracks and the pavement surface only showed signs of weathering and rutting. As the last rehabilitation on this portion was in 1998, the lack of cracking shows that the pavement section has a strong base structure. Overall, the main distress in Taxiway A was weathering/raveling. Polished aggregate, rutting, longitudinal cracking and a few minor depressions were other distresses found along the taxiway.

In several locations, popouts were found in the PFC caused by spalling of the surface.

*Image: 1.3.2.1 PFC Popout on Taxiway A*

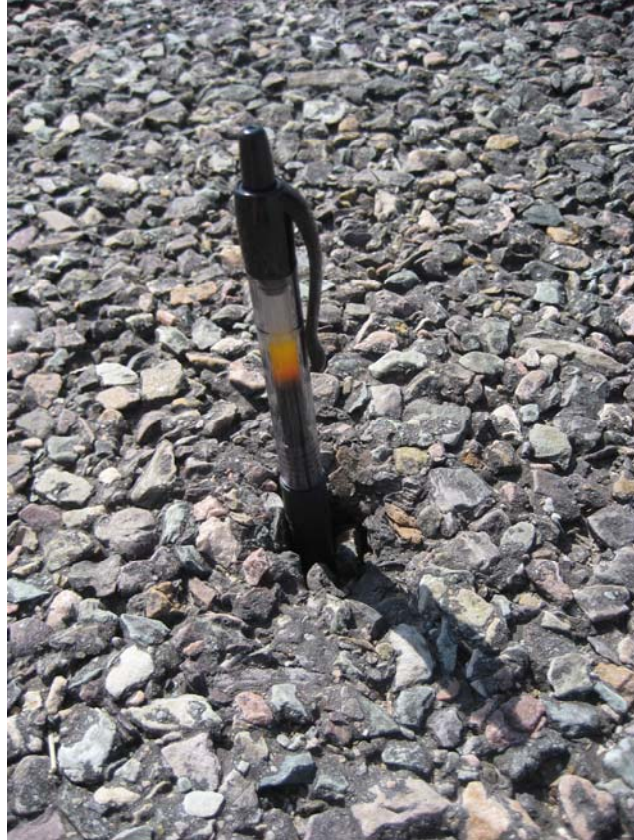
*Image: 1.3.2.2 PFC Popout on Taxiway A*

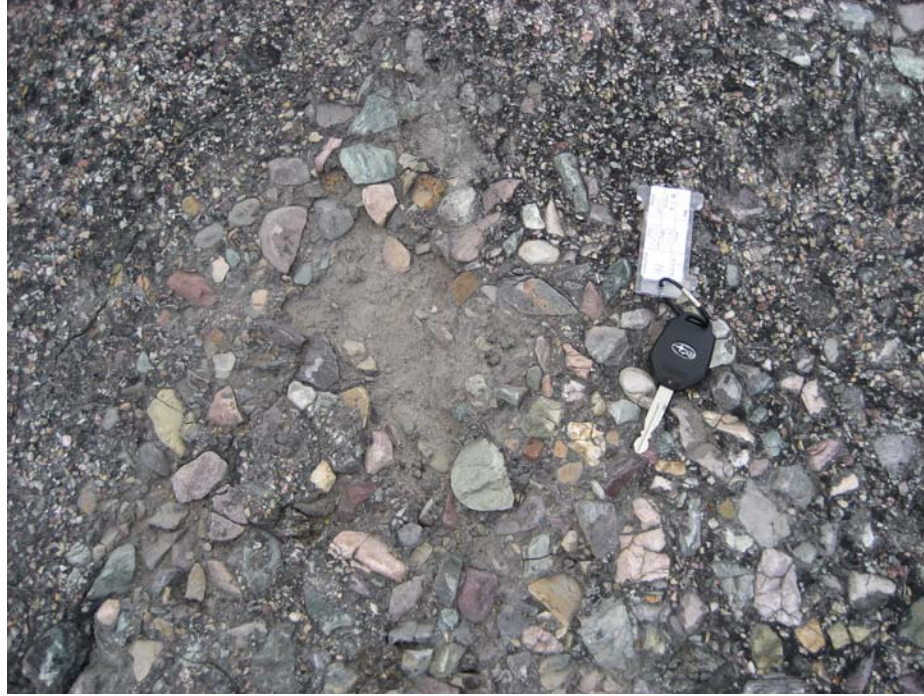
Taxiway E is a frequently-used taxiway as it is the preferred taxiway for aircraft using the apron. It is in “very poor” condition with a PCI value of 27. Taxiway E connects Taxiway A to the main terminal apron. A small portion of the taxiway connecting to Runway 7/25 was rehabilitated in 1998. This portion received a PCI value of 62 and was in “fair” shape. However, the larger section of Taxiway E contains low to high severity weathering and raveling, patching, longitudinal and transverse cracking, depressions and bleeding.

*Image 1.3.2.3 High Severity Weathering on Taxiway E*

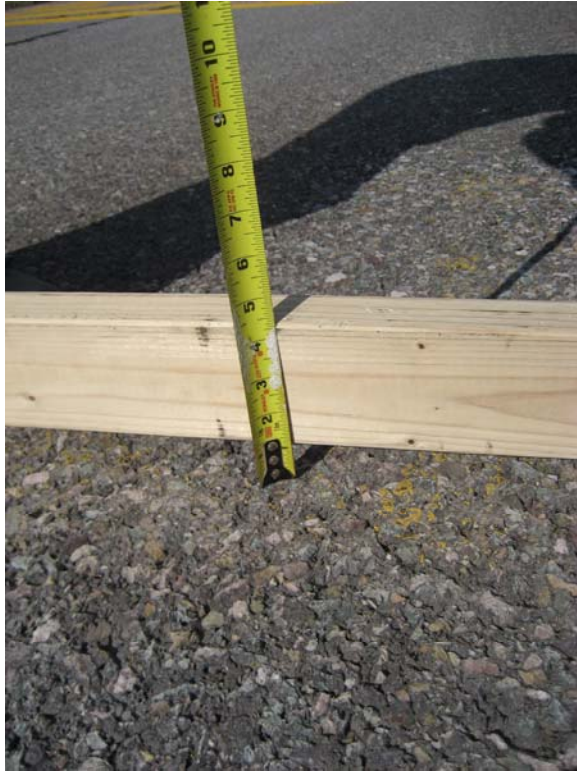
Taxiway G is a highly used taxiway connecting Runway 7/25, through Runway 11/29 and Taxiway A, to the West General Aviation Apron and Smoke Jumper Apron. The portion connecting Taxiway A to the aprons was rehabilitated in 2004 and is in “satisfactory” condition with an area weighted PCI value of 77. The main distresses found were low to medium severity weather and raveling and a couple low severity depressions.

*Image 1.3.2.4 Medium Severity (1" depth) Depression on the Northern Portion of Taxiway G*

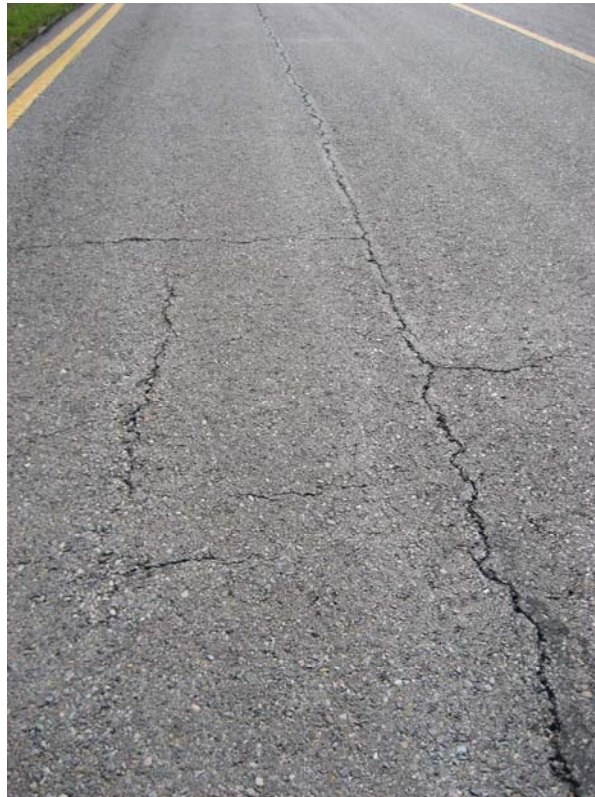
The two connecting portions of Taxiway G were constructed in 1975. The area weighted PCI value for the sections is 61, “fair” condition. The distresses noted include: low to medium severity weathering, patching, depressions, rutting, and block, alligator, longitudinal and transverse cracking.

*Image 1.3.2.5 Block Cracking on the Southern Portion of Taxiway G*

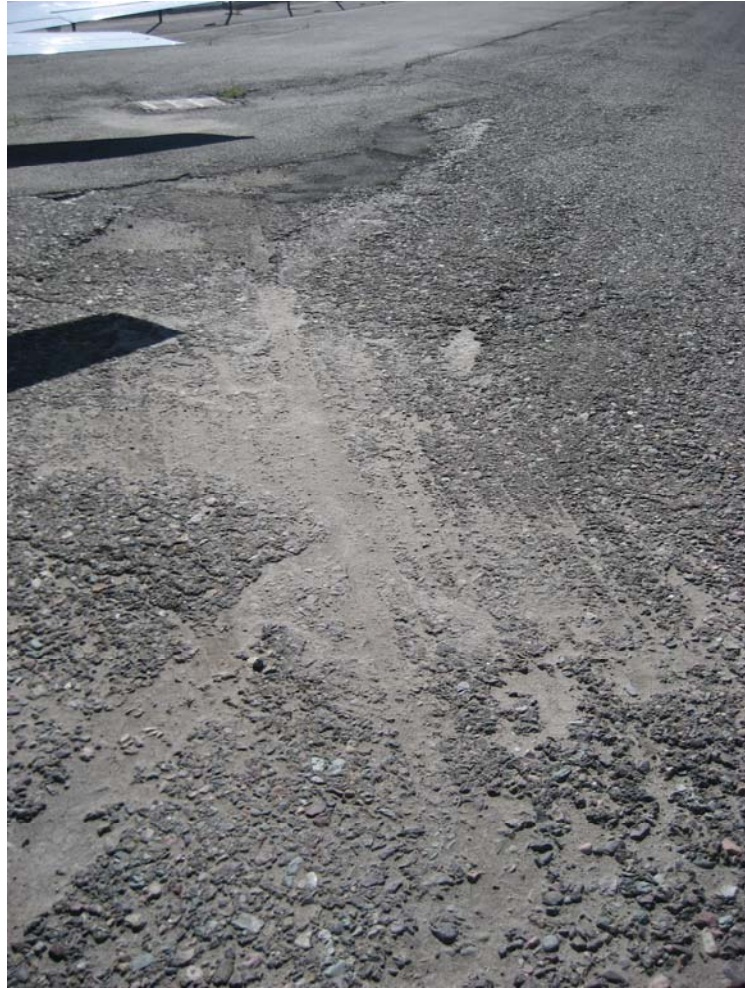
The portion in front of the snow removal equipment building (GA-West 4) is affected by the large machinery which, due to their heavy loads, deteriorates the pavement. The PCI value for GA-West 4 is 69. Distresses observed include: patching, depressions, block, joint reflection, longitudinal and transverse cracking, weathering and raveling, polished aggregate, and various oil spillages. The severity level ranged from low to high for most of the distresses, due to the damage from the snow removal equipment over time.

*Image 1.3.3.1 High Severity Weathering on General Aviation Apron-West (GA-West4)*

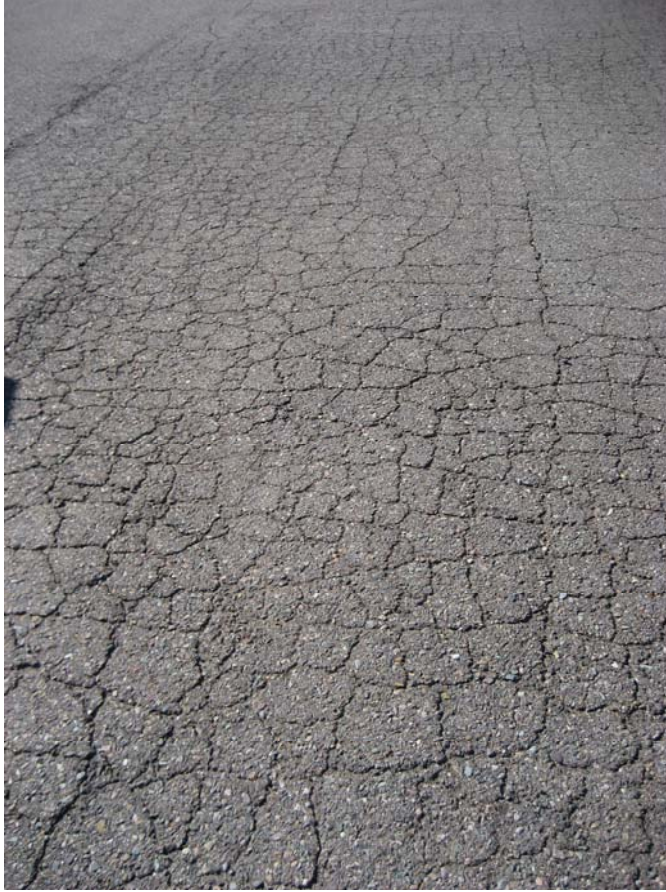
The Airborne Apron was a section added to the field survey sampling areas on the General Aviation Apron-West during the field visit. The Airborne Apron was noted to be in extremely poor condition. The apron has never been rehabilitated and was built in the late 1960s. The area weighted PCI value is 36; “very poor” condition. High severity levels of weather and raveling, depressions, patching, longitudinal and transverse cracking were found on this apron.

*1.3.3.2 Medium Severity Alligator Cracking on the Airborne Apron*

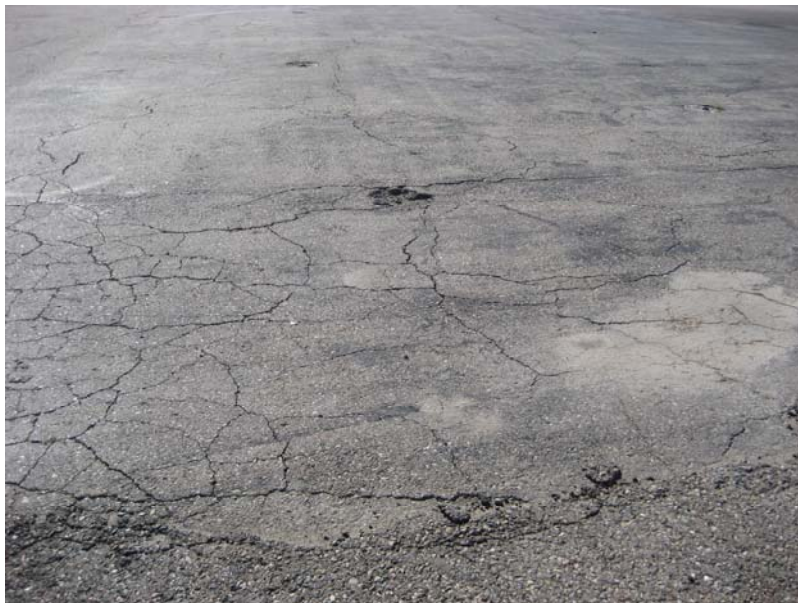
*1.3.3.3 Medium Severity Alligator Cracking and High Severity Raveling causing Excessive FOD on the Airborne Apron*
