# **Environmental Compliance Assessment**

**Missoula International Airport**

Prepared for  
**Missoula County Airport Authority**

MARCH 2008

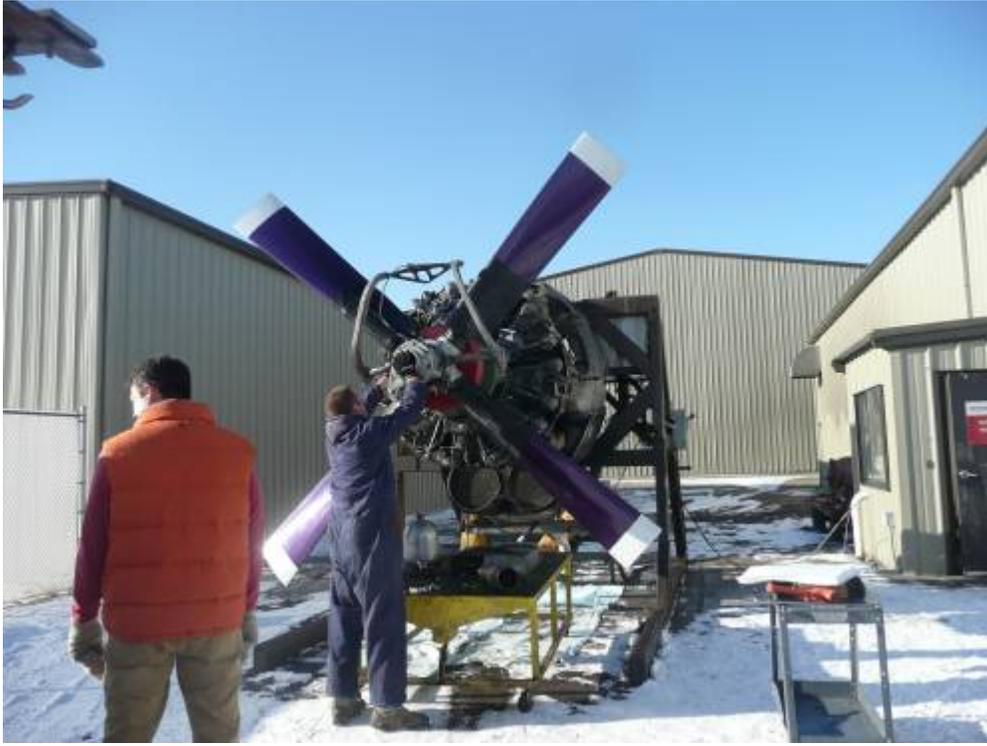
The engine test stand operation at Neptune results in generation of used oil, some of which may end up in nearby storm water outfall # 15. Oil was present on the ground and pavement around the engine test area. During engine testing, some oil is discharged into the air via the engine exhaust, or blown into the air by the prop wash. The oil that is exhausted or blown from the engine is deposited onto the gravel behind the engine, and on building walls. An underground oil/water separator is installed near the engine test stand to treat runoff and reduce oil impacts on storm water. However, there is a potential that not all oily run-off is captured and adequately treated by the oil/water separator.

Neptune indicated that a "barrier" has been installed under the gravel area to prevent subsurface soil contamination; this product was also alternatively described as a "stress absorbing fabric" incapable of providing a true impermeable barrier. Neptune also applies a surface washing chemical Petro-Green to promote biological degradation of the deposited petroleum. These efforts to control oily runoff from the engine test pad are commendable, including installation of the oil water separator, however, the operation is not in compliance with the regulatory intent of the general permit (Part IV.A) "to remove pollutants contained in storm water runoff" and the SWPPP, "Preventative Maintenance Program" (Section 3.4) requiring that operations be "kept clean and in neat order to reduce the possibility of storm water runoff contamination." Furthermore, the operation also presents potential future environmental contaminant risk and regulatory action due to the accumulated contamination of oil in the gravel.

**Proposed Action:** Re-evaluate the test stand operation and revise procedures and engineering controls with the goal "to remove pollutants contained in storm water runoff". The engineering controls needs to consider a design modification to capture airborne contaminants and eliminate deposition on the soil. Evaluate the effectiveness of the existing storm water run-off design to improve flow off the pad to the oil water separator. Design and implement engineering controls to eliminate contamination of gravel surrounding the test pad.

Neptune Engine Test Stand: Re-evaluate the test stand operation and revise procedures and engineering controls with the goal "to remove pollutants contained in storm water runoff". Also, suggest possible re-design and implementation of engineering controls to eliminate contamination of gravel surrounding the test pad.

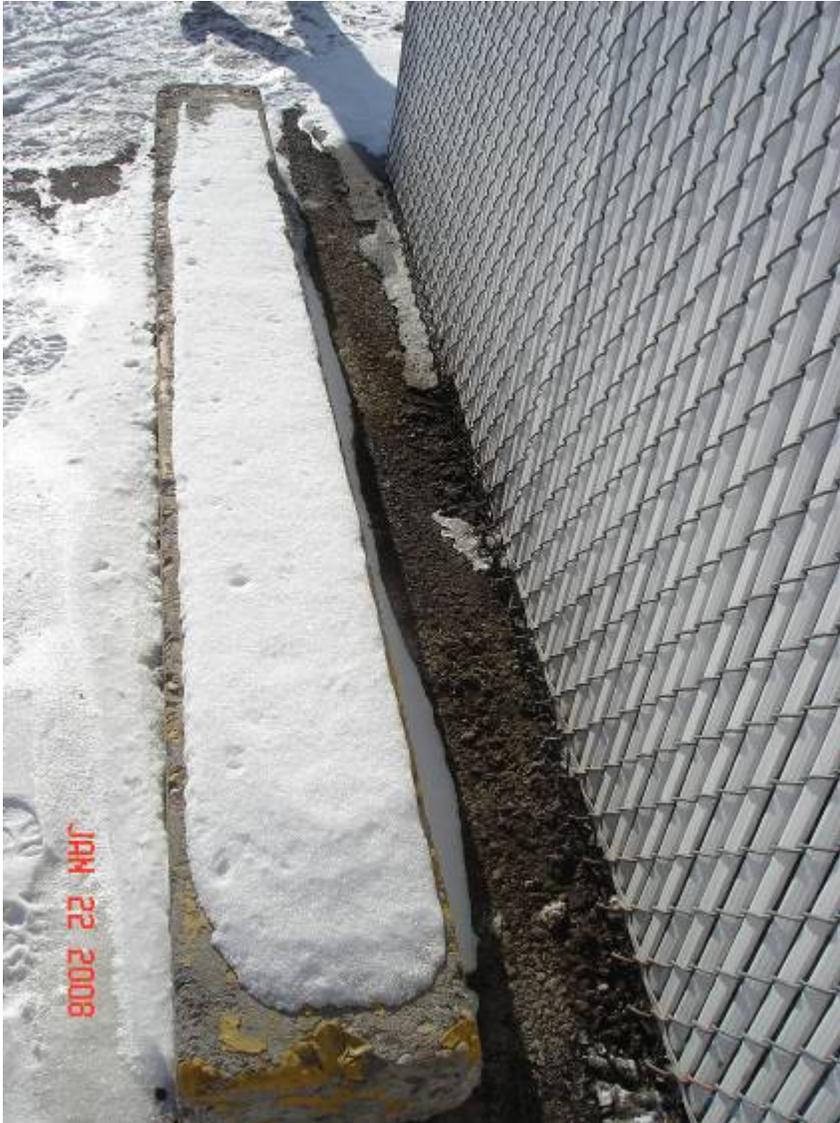
Neptune Engine Test Stand: Stormwater runoff controls off the engine test pad do not appear to fully direct stormwater to the underground oil/water interceptor; some staining of soil was evident.

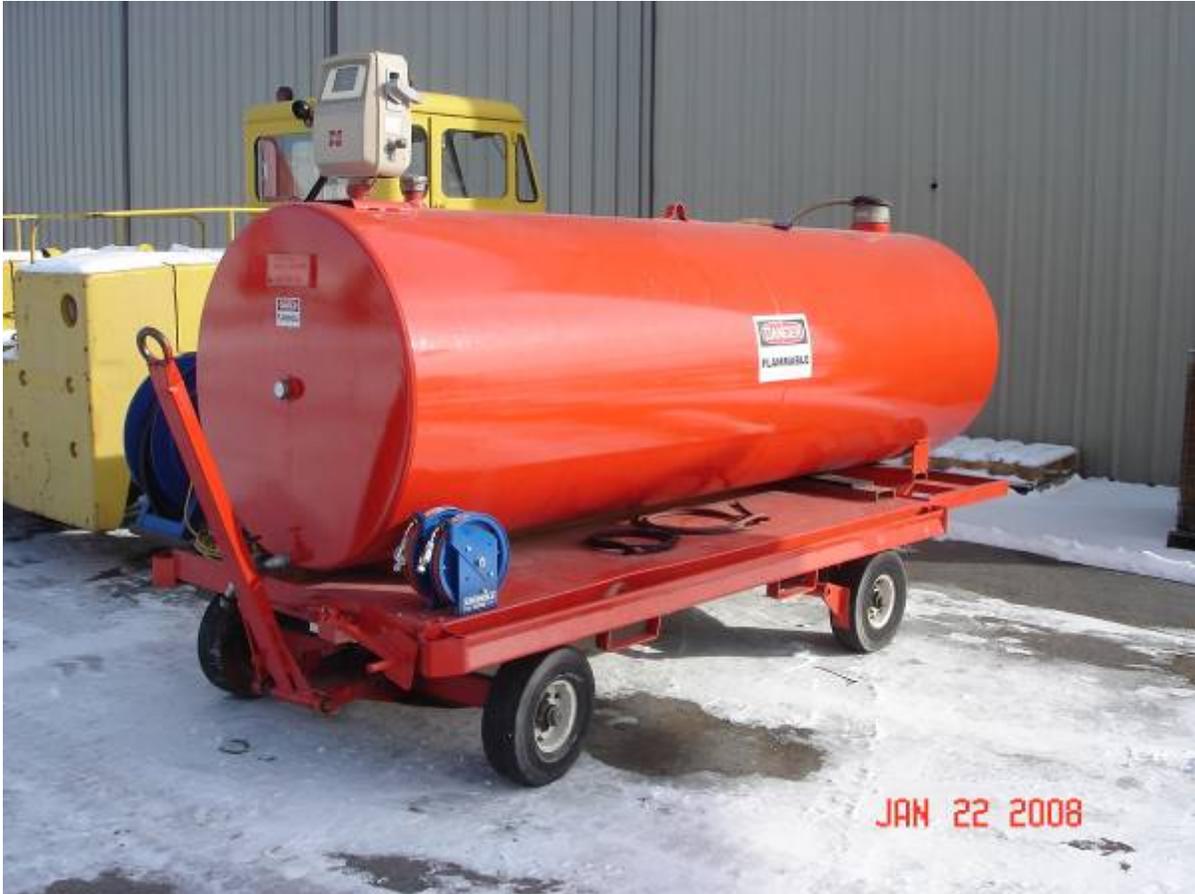
When not empty, mobile refuelers are subject to the general secondary containment requirements in the SPCC regulations. The current SPCC plan indicates that refuelers and mobile tanks will be staged in 2 locations; one near the Minuteman Ops Center and one outside the Neptune hanger. Other mobile refuelers were observed throughout the facility in areas that are not designated as areas that would prevent an impact to surface waters in the event of a spill. Specific provisions are required to be implemented to prevent discharged of petroleum products from reaching navigable water courses.

**Proposed Action:** Review the storage and staging areas for non-empty mobile refuelers and mobile storage tanks at the airport. Store non-empty mobile containers

within designated areas, and/or revise the SPCC plan as necessary. Provide appropriate containment and/or diversionary structures or equipment to prevent a discharge that may be harmful.

Airport Wide: Methods need to be developed to prevent discharges from non-empty mobile tanks that may be harmful to the environment. Many options exist including use or combination of dikes, berms, or retaining walls sufficiently impervious to contain oil; curbing; culverting, gutters, or other drainage systems; weirs, booms, or other barriers; spill diversion ponds; retention ponds; or sorbent materials. It will not always be necessary to install containment structures to comply with the regulations, in some situations it will be acceptable to have a spill kit on site and perform regular inspections of the equipment to make sure it is in good condition and not leaking.

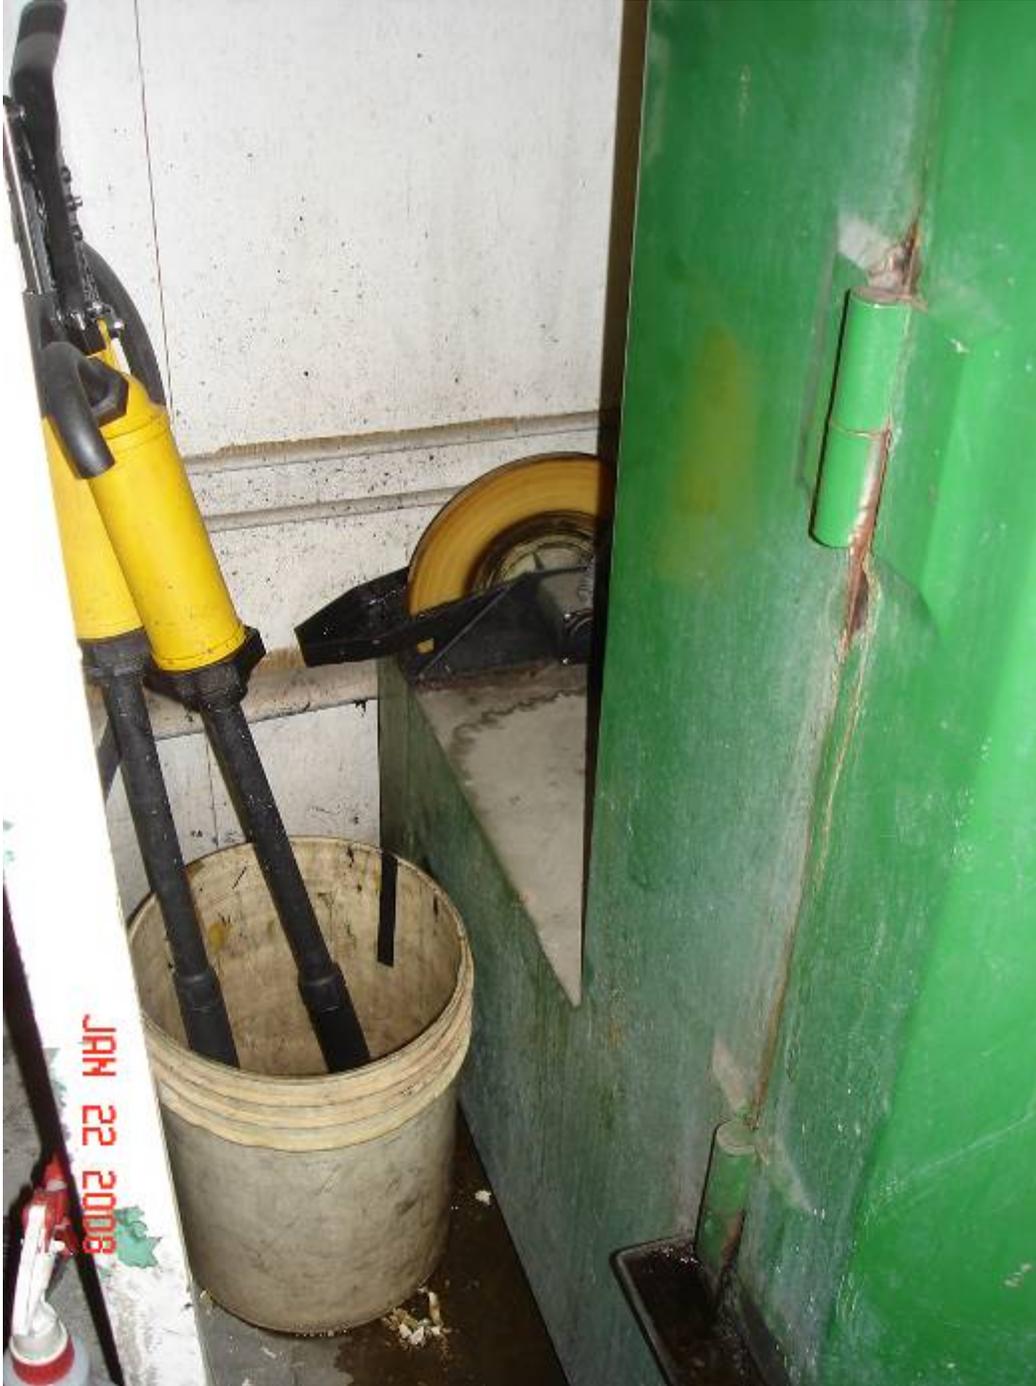
Waste characterization has not been conducted to determine if certain waste streams are hazardous. For example, skimmer sludge from two aqueous parts washers in the Neptune Main Hangar and Engine shop, paint booth filters, and a 5-gallon container used to consolidate paint waste have not been characterized. Safety Kleen provides solvent pickup and replacement service. At the time of the assessment, records were not available to demonstrate whether or not the solvent is a hazardous waste.

**Proposed Action:** Perform hazardous waste characterization to determine if the waste streams need to be managed as hazardous waste in accordance with Administrative Rules of Montana (ARM). Inventory all waste streams and determine whether wastes are hazardous using knowledge of the constituents of the waste (from MSDSs); whether it is listed in 40 CFR 261; laboratory analysis; and/or knowledge of processes and/or materials used. Once the wastes are characterized, the hazardous waste quantities need to be documented to formally determine generator status (Conditionally Exempt Small Quantity Generator, Small Quantity Generator, or Generator). CH2M HILL has contacted Safety Kleen to obtain waste generation data on the Airport and tenants; these records will be used to ascertain hazardous waste generation status.

Airport Wide: Waste generation points should be characterized to ensure the proper disposal pathway is utilized. Sludge off the skimmer of an aqueous parts washer may contain heavy metals in concentrations that may require disposal of the product as hazardous waste. The volume of the waste, no matter how minimal, still requires proper management and disposal.

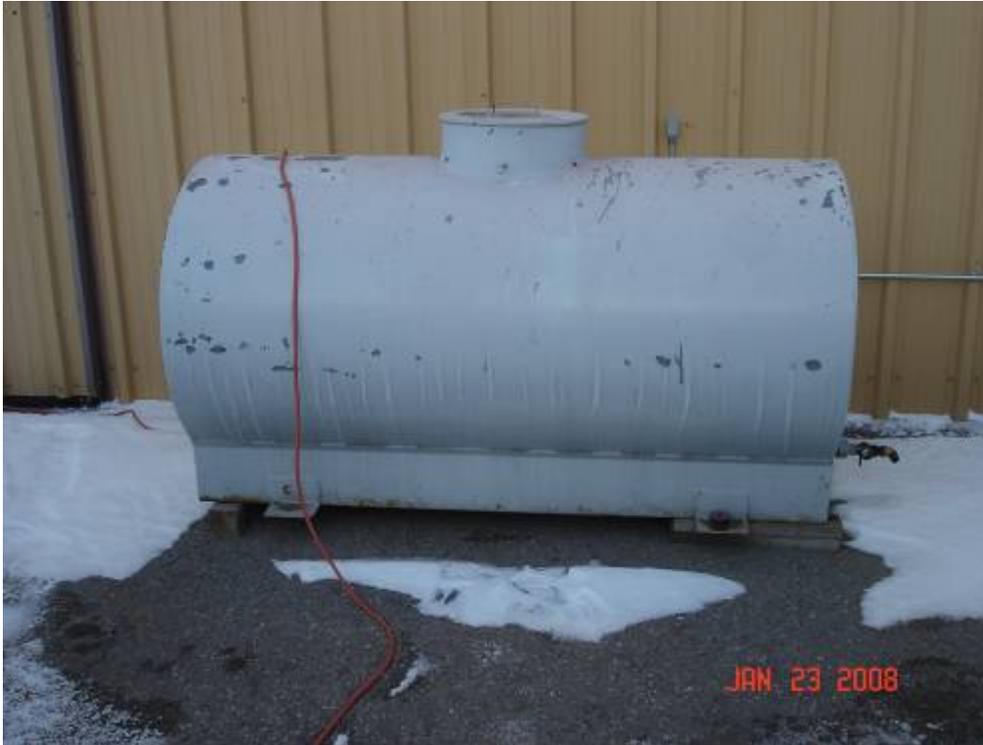
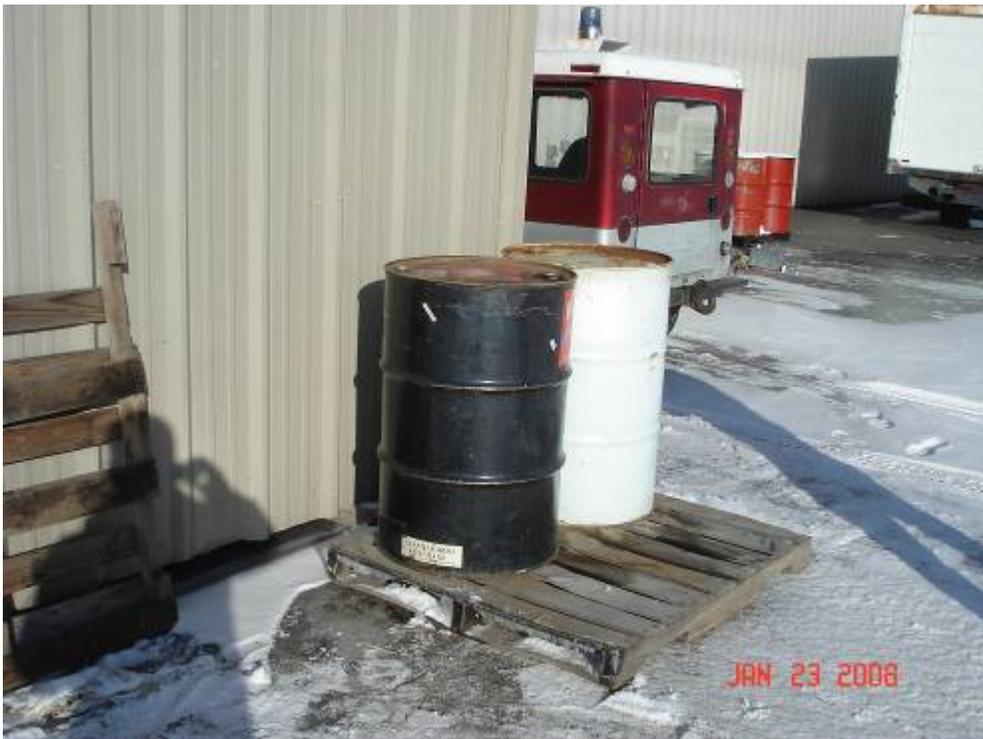
Numerous 55-gallon drums and small storage tanks were observed inside and outside of buildings, on pallets and on the ground. Those outside did not have secondary containment. It was difficult to determine if those inside had adequate secondary containment provided by the building itself. These containers held new oil, used oil, and Jet A fuel and other petroleum products that has been sumped from trucks and tanks and is awaiting re-use or disposal. The SPCC rules require secondary containment for these bulk storage containers. Containment can be a building, storage area, or sized containment structure. The absence of secondary containment for small bulk storage containers was noted in particular inside and outside of the Minuteman maintenance building, in the Airlines equipment storage areas, and in an area between the Minuteman and Aerotronics storage buildings.

**Proposed Action:** Review all bulk storage containers 55-gallons and greater and evaluate appropriate methods for providing secondary containment. Determine if some of the storage areas can be consolidated, or eliminated. Ensure that sized secondary containment is provided for bulk storage containers. For containers that must be stored outside, consider use of methods to prevent stormwater contact.

Airport Wide: Non-empty, stationary, non-mobile tanks and containers greater than or equal to 55 gallons require secondary containment. It is also highly recommended that tanks and containers stored outside be covered to prevent contact with stormwater.

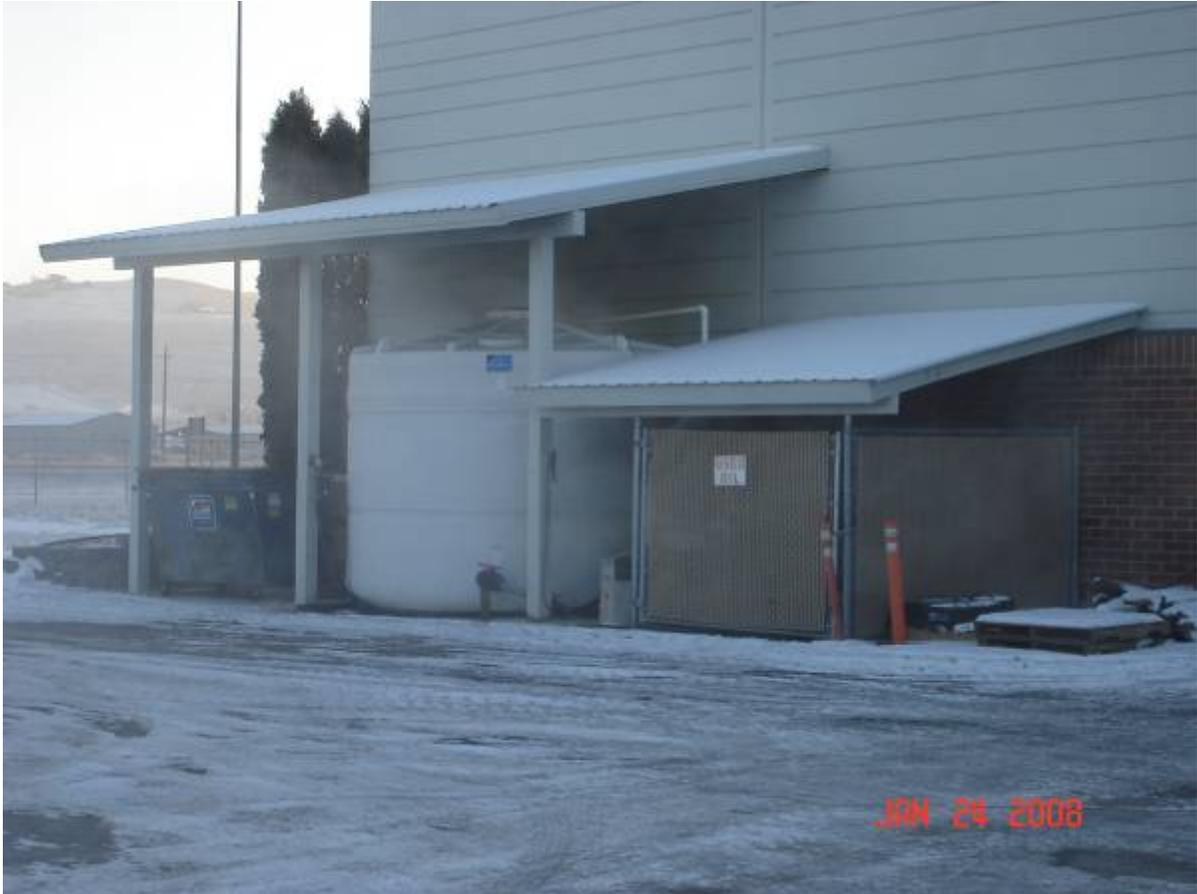
Airport Wide: Construction of overhangs over hazardous chemicals and used product storage areas is an excellent way to prevent rainwater contact with product and waste and thus reduce harmful stormwater discharges.

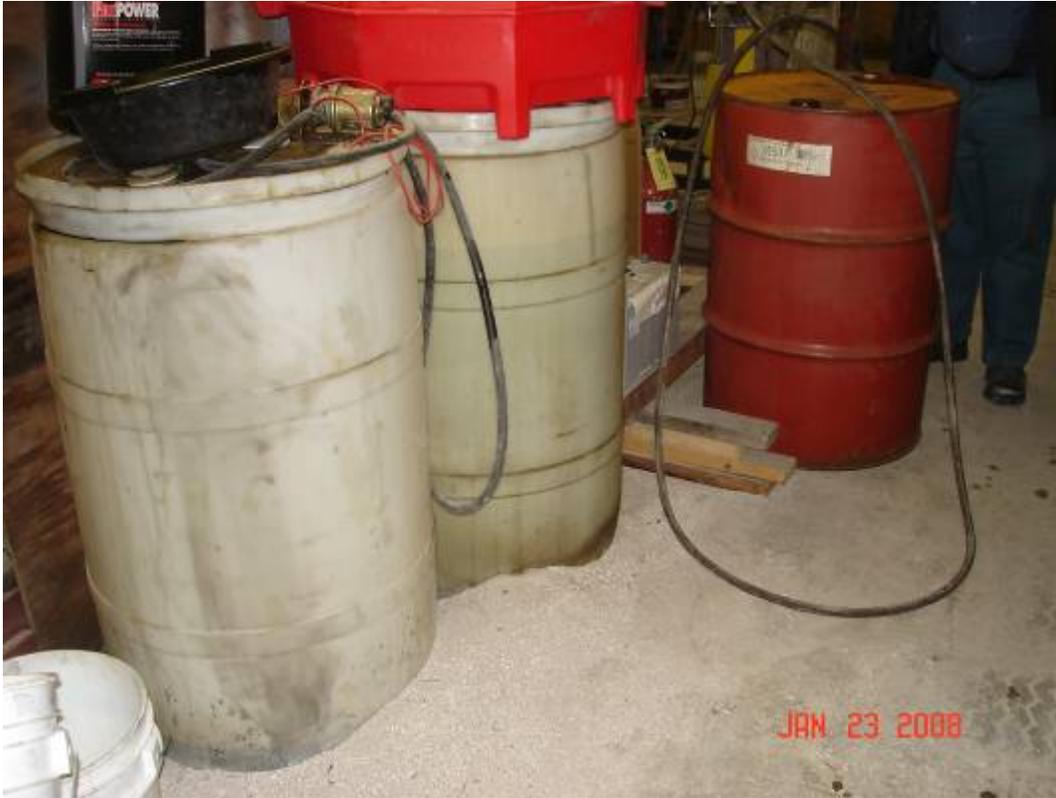
Airport Wide: A commendable effort was undertaken to control drips and leaks from containers. Another more effective option would be to use pallets with built-in secondary containment.

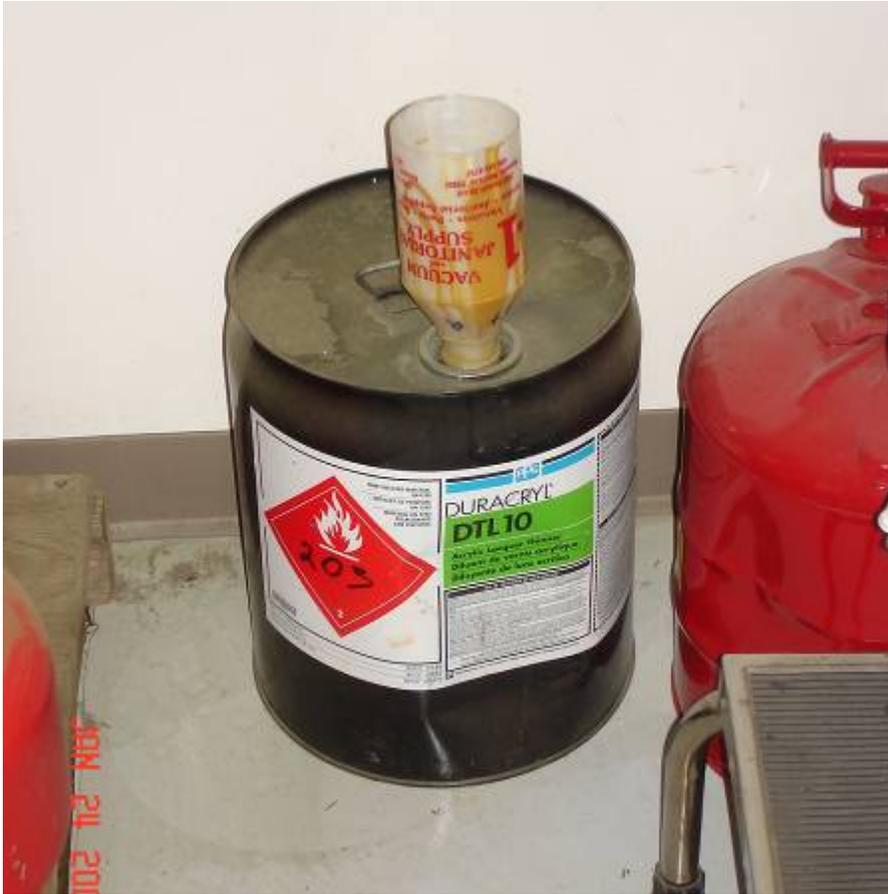
Aerosol cans are considered hazardous waste if they are disposed of while still pressurized. Depending on the contents, they also may be a hazardous waste if they contain more than a trace of the original contents when disposed. Aerosol cans are extensively used in the airport facilities and are generally disposed in dumpsters after use. Aerosol cans should be properly managed prior to disposal in dumpsters.

**Proposed Action:** Manage aerosol cans by puncturing after use and collecting residual contents into a small container. The spent can then be recycled for scrap or disposed. Commercial puncturing devices are available for this purpose. The collected drained material is typically managed as a hazardous waste.

Airport Wide: Paint waste, particularly from aerosol paint cans, should be managed as hazardous waste and disposed of by licensed transporters. Aerosol paint cans should be punctured, residual contents drained into a drum. The spent paint can then may be disposed of in the trash.

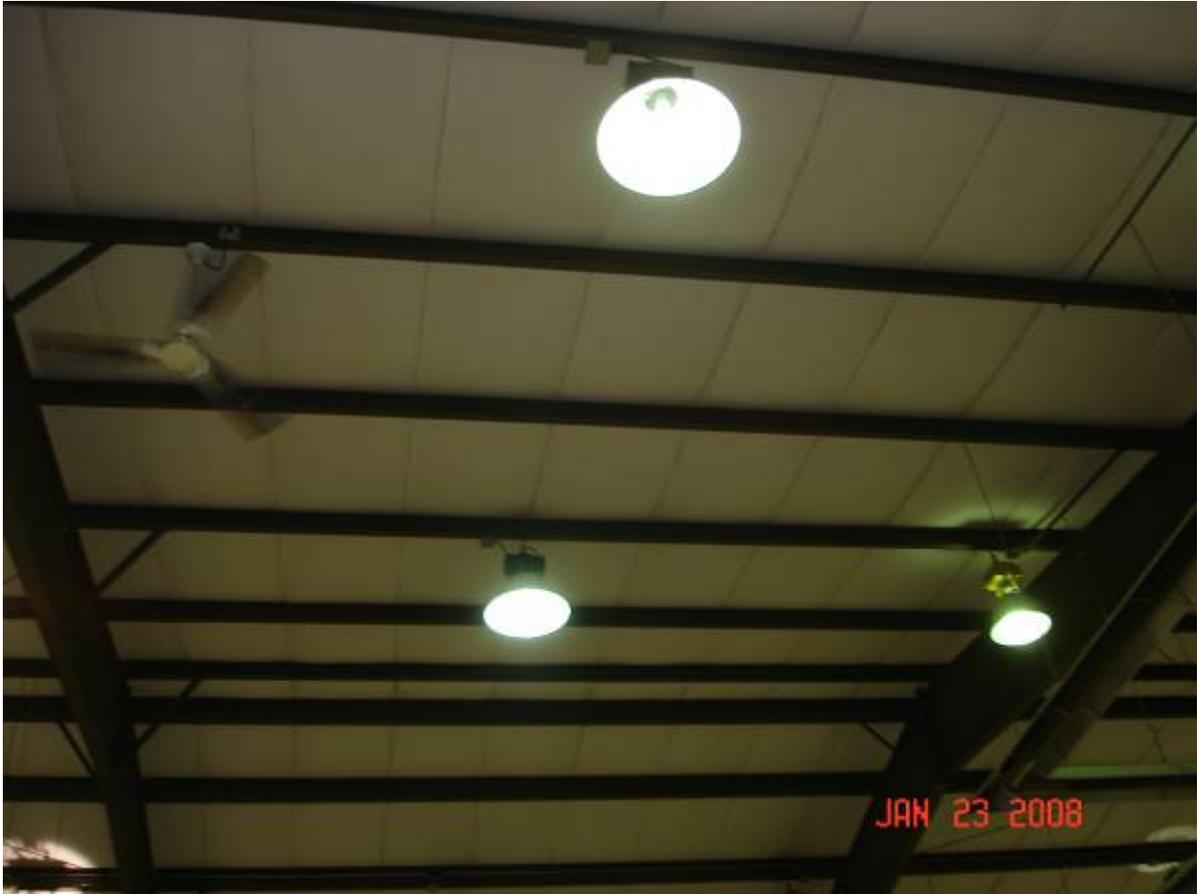
Universal wastes (spent electric tubes or bulbs containing heavy metals, spent batteries other than lead acid, suspended or cancelled pesticides and mercury containing wastes) are not properly managed to comply with federal and state regulatory requirements. In general, waste lamps are disposed in the trash, and accumulation areas for batteries or other materials that may become universal wastes are not properly accumulated and stored in closed containers. Also there are no records or systems in place to prove that universal wastes are not stored on airport property greater than one year.

**Proposed Action:** Establish a program to collect, store, and mark universal wastes to ensure that they are properly managed or disposed. The airport has one year from the date on the container to properly dispose of universal wastes.

Airport Wide: Burnt out lights, particularly fluorescent bulbs and lights with heavy metals, should not be disposed of in dumpsters. They should be recycled and spent bulbs not stored on the facility for longer than 1 year.
